FLEET IMPROVEMENT CAMPAIGN FI0377

SUBJECT: Improperly drilled air regeneration passage in the Haldex Air Dryer.

Haldex Air Dryer Replacement

Bulletin # AD0698-1

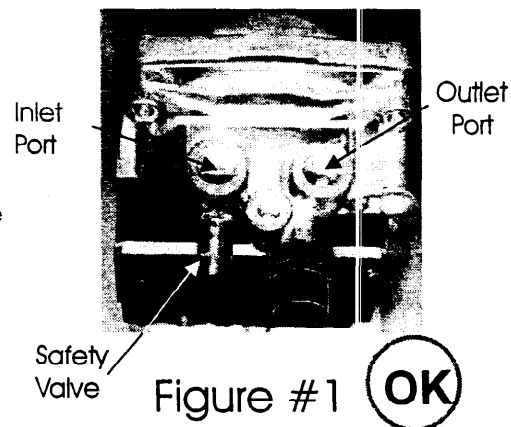
Figure #1

Illustrates an older design that does not have to be replaced. This is identified by the position of the safety valve. The valve is located directly below the dryer inlet on the left side of the dryer.

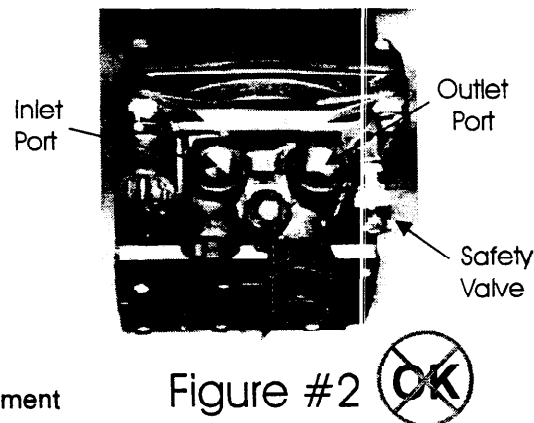
Figure #2

For Haldex dryer models utilizing "System Air" for desiccant regeneration. There were a limited number of these dryers produced that do not provide an internal passage in the housing to regenerate the desiccant. Without this passage, the dryer will act like a condenser and in time, will accumulate water in the reservoir system.

Illustrates the current design that must be replaced. This design has the safety valve mounted to the right side of the dryer outlet.

- Check vehicle dryer configuration (as shown above) to determine if replacement is needed. For these air dryers identified to be the configuration shown in Figure #2, Haldex will supply replacement dryers.

- Open drain valves and drain all reservoirs to "0" psi.
- Disconnect air lines from dryer and remove dryer from vehicle. Re-use fittings.
- Install new dryer and torque the 3 mounting bolts to 40-50 ft-lbs.

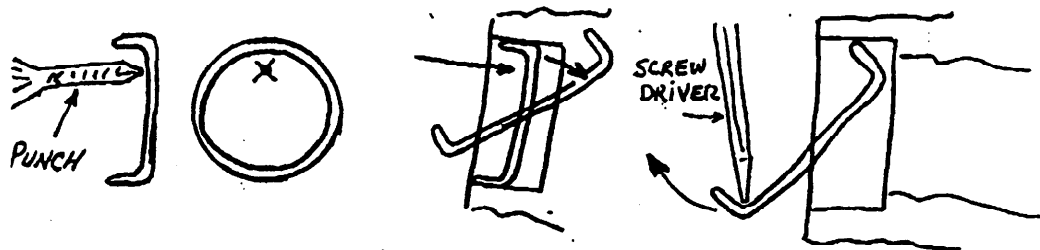
- ⇒ Depending upon which head is to be inspected, and fuel filter and EECU locations, remove what is necessary to gain access to the cup plug which is to be removed. The worst case entails removal of module, fuel filters, inlet manifold and both water manifolds. Remove only what is necessary to gain access to the cup plug which is to be removed.
- ⇒ Using a drift punch and a screw driver (See Illustration), remove the plug by prying out of head. **DO NOT DRIVE THE PLUG INTO THE WATER JACKET, IT MUST BE REMOVED.**

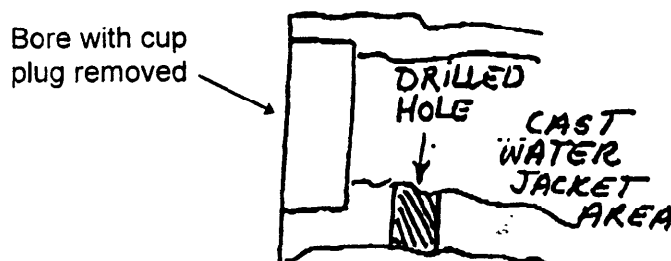
- ⇒ With the plug removed, look inside the water jacket of the head for the presence of a $\frac{1}{2}$ " diameter hole, approximately 1" in from the outside surface, at the 6:00 position (See Illustration). If no hole is present, this is a good head and reassembly can begin. If a drilled hole is evident, this is an incorrect head and must be removed from the engine and replaced with a correct head.

- ⇒ If the $\frac{1}{2}$ " hole is visible inside of water jacket, cylinder head must be replaced.
- ⇒ If the head is okay, reinstall a new cup plug, P/N 79AX63Z using the following process:
 - ◆ Clean the cup plug bore using Loctite cleaner #7-555-9 or equivalent solvent cleaner.
 - ◆ Apply a coating of Loctite #277 or equivalent to the bore and to the outer edge of the cup plug.
 - ◆ Using cup plug installation tool #J34684, drive the new plug into the bore making sure that the installation is square to the surface and slightly below a flush condition.
 - ◆ Complete reassembly, coolant fill, check coolant with a test strip, run and check for leaks.
